TEAL LAKE DAM
AUDRAIN COUNTY, MISSOURI
MO. 10082

PHASE I INSPECTION REPORT NATIONAL DAM SAFETY PROGRAM.

Teal Lake Dam (MO-10082), Missouri - Kansas
City River Basin. Audrain County, Missouri
Phase I Inspection Report.

NOVEMBER, 1980

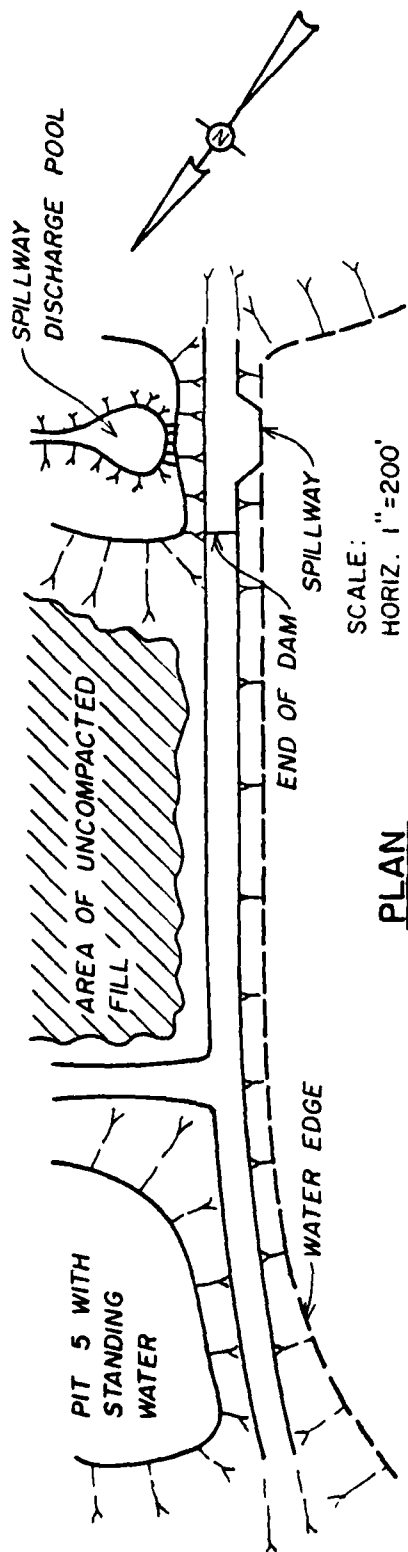
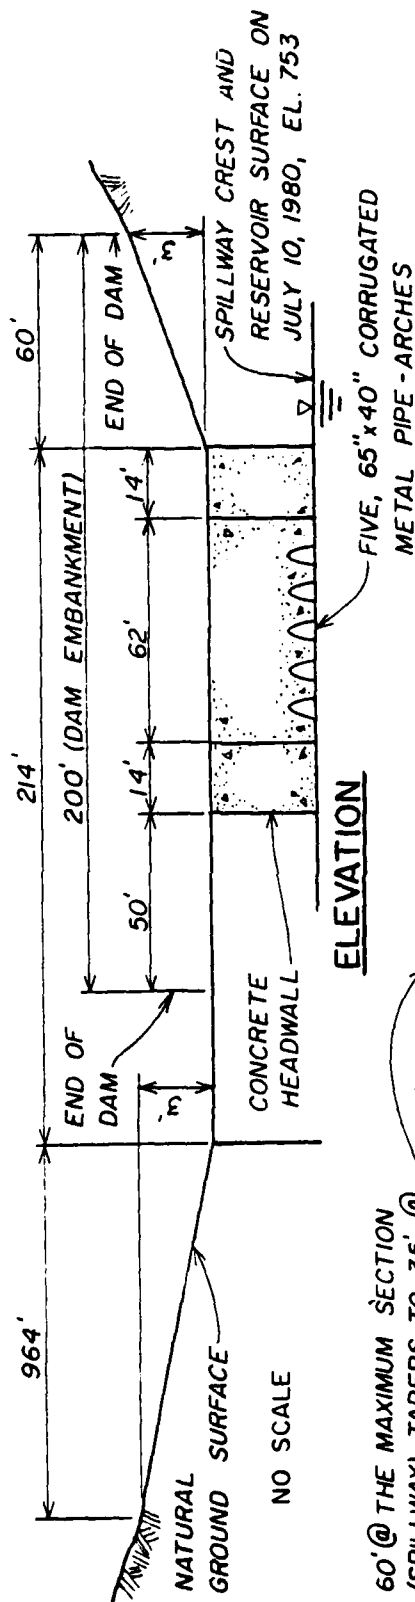
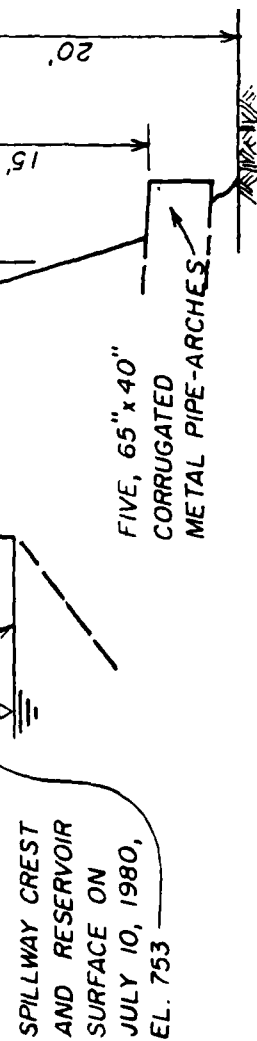
TEAL LAKE DAM (MO. 10082)
PLAN, ELEVATION &
MAXIMUM SECTION OF EMBANKMENT

60' @ THE MAXIMUM SECTION (SPILLWAY), TAPERS TO 35' @ EACH END OF SPILLWAY

U/S SLOPE IS VERTICAL AT CONCRETE HEADWALL AND 1 V : 2.25 H @ EARTHEN SECTION

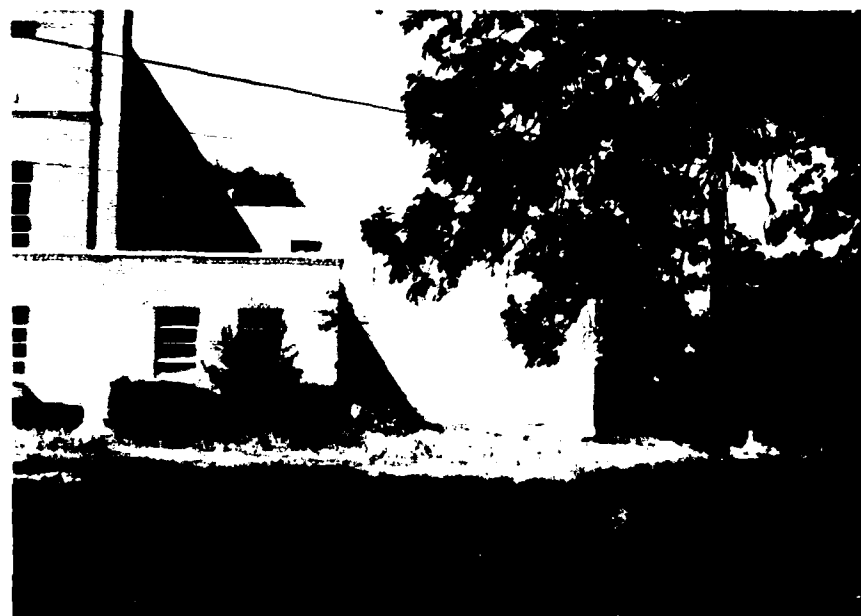
Photo 14 - View of the Military school believed to be in the downstream hazard zone with the downstream channel to the right of the photo.
